A report on the activities of the Colvin Crew
 In the vicinity of Middle Saranac Lake
 June 21 and 22, 2008

Based upon V. Colvin's 1874 report to the state legislature, a two-day outing was undertaken by the "crew" in an attempt to "follow in the footsteps" of our namesake. Our activities would be limited to finding his measured baseline located on Middle Saranac Lake, along with its corresponding primary triangulation station on nearby Ampersand Mountain. Colvin's observations from Ampersand Mountain allowed for an extension of his existing high peak network, northwesterly into the St. Regis area via St. Regis Mountain and southwesterly into the Tupper Lake area via Mt Morris. Additionally, the nearby township line separating Lots 23 & 24 in McCombs Purchase would be investigated.

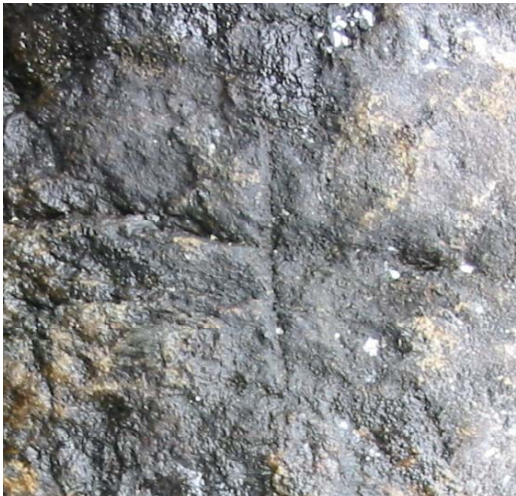
Photo 1

Based upon the late winter date of the field work, I can only surmise that this measurement was performed in accordance with his normal baseline measuring practice of having a horse driven plow team clear a path through the snow on top of the only large level area available (a lake) that would on a warm sunny late winter day, collect and maintain a trough of unfrozen water thereby providing a level chaining surface of a uniform temperature in which his 1,000 feet long pre-calibrated steel ribbon could be immersed in. So, at 2:20 pm with an instrument setup on Bolt 48 to keep the tape in alignment with an “x” mark made at the base of the boulder in which Bolt 49 rests apron⁴. The tape was stretched and the distance between bolts was found to be 4,983.150 feet. Total elapsed time of measurement was 2 hours and 12 minutes in which V. Colvin computed a taping speed of 37 feet per minute⁵.

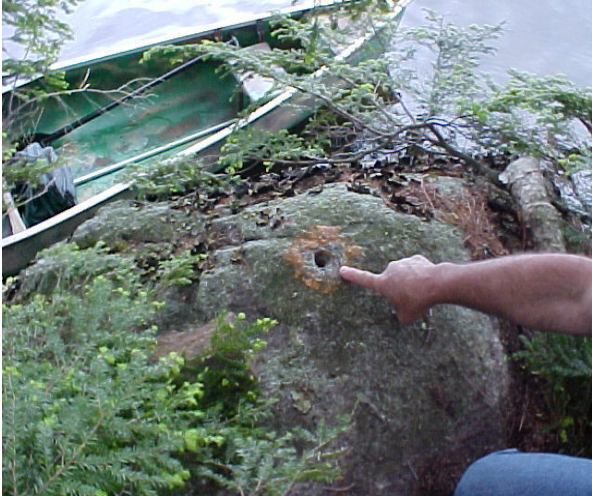
Photo 2

The location of Bolt "J" was found quickly enough as a blazed and yellow painted line was observed extending southerly from the lakeshore denoting the boundary line between N.Y.S. and private holdings. Unfortunately, the original nickel plated copper bolt had been removed and only the drill hole remained⁸. A bearing was taken on the blazed line and by its reverse, a mark on the opposite shore (1.2± miles) away was selected as the search location for Bolt "I". A brief rainstorm was encountered while crossing the lake that would set the stage for a day of intermittent showers. Upon arriving on the north shore of Middle Saranac Lake in the vicinity of our projected bearing, a search was made for any evidence that would help us in locating Bolt "I". In short order, a shout arose from one of the crew (who was resting in his canoe after his exertions in having *others* paddle him across the lake) saying he had found a drill hole in a rock along the shoreline. Sure enough, that was all that was left of Bolt "I" as vandals had beat us there again and the bolt was gone⁹.

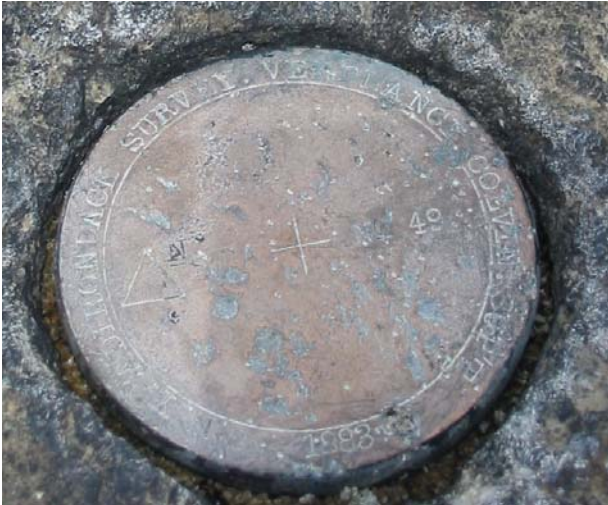
Photo 4

With our spirits slightly dampened, we set a course for primary triangulation station 49, located on the southerly side of Halfway Island. After a brief paddle and with the use of V. Colvin's field book sketch, Bolt 49 was quickly located and found to be in good condition¹⁰. Of interest is the year 1883 found stamped on the bolt vs. the measurement date of 1891¹¹. Obviously, Colvin had utilized this point many times over the years between 1873 and 1891; thereby presenting the possibility that the bolt found today was a replacement for an earlier mark.

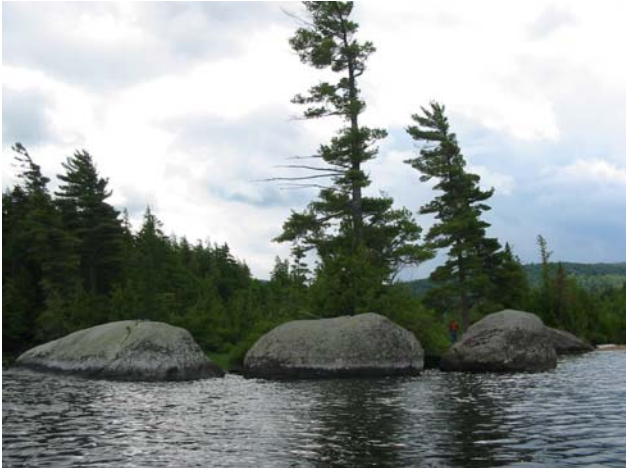
Photo 5

With our faith revived, we struck out back across the lake to find our final point, Bolt 48. This point was described as "being on top of the middle boulder of a three boulder point difficult to ascend"¹². Within short order the error in V. Colvin's sketch location was discovered and we identified the correct location along the shoreline¹³. True to the notes, it was "difficult to ascend". We found the stem of the original bolt minus its head, which had been removed¹⁴. Due to the confusion in finding this last point along with the desire to verify the distance between Bolts 48 and 49, a detail was sent back to the vehicles to collect the survey gear. Upon arriving back at Bolt 48, a boat team was dispatched to erect a signal across the lake on Bolt 49. In between passing showers, a measurement was obtained of 4,983.250 feet (±5mm + 5ppm) vs. the record distance of 4,983.150 feet¹⁵. Having thus completed the scheduled recovery, the boats were loaded and the day's activities ended with the crew retiring to their campsites by 3:30pm. In the evening, the crew reassembled at a fine restaurant in Saranac Lake where we were able to sufficiently revive ourselves after the day's strenuous adventure.

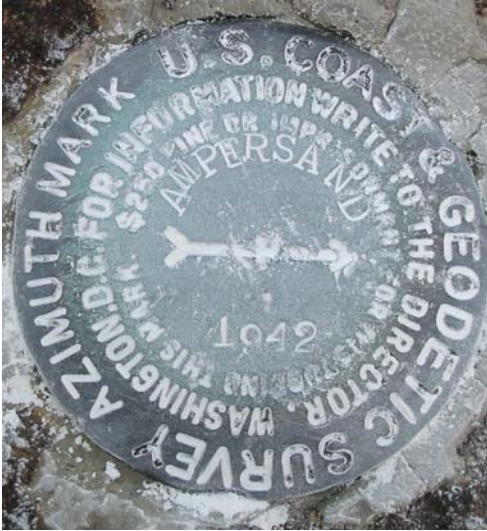
Photo 7

“The weather turned out fine with only a brief shower (*isn't that typical*). The view from the top was clear with many high peaks visible. A USC&GS standard disk stamped “Ampersand 1942” was found on the highest point¹⁶ with a *solitary* drill hole residing 10 inches away in an easterly direction¹⁷. Additionally, the location of three of the four “stan-helio” anchor points (eye bolts) were recovered, the fourth falling on an area of cleaved rock and destroyed¹⁸. After a brief exploration of the ridge line located westerly of the summit in which an azimuth mark was found for the USC&GS disk, the mountain was descended safely and the crews activity concluded for the weekend”.

As to whether the *solitary* drill hole or the USC&GS mark best represents the location of Colvin’s Bolt 13, I have submitted a request to the NGS (formerly USC&GS) for their 1942 field notes in the hopes of clarifying this issue. If successful, I will submit an addendum to a future recovery report with the details.
